## Survey Report on the Reconstruction Following the Earthquake in Marmara, Turkey on August 17, 1999

Tetsushi Kurita  
Senior Researcher, Asian Disaster Reduction Center

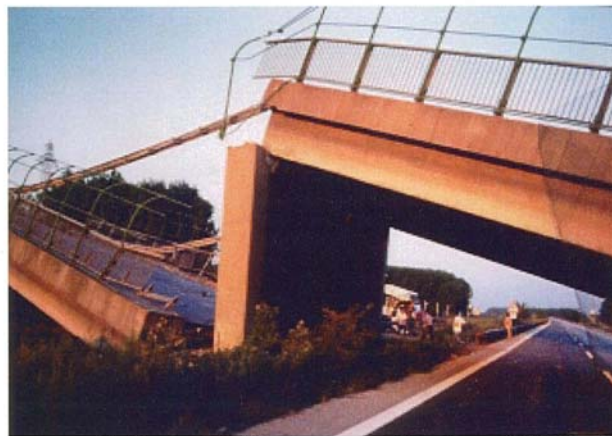
Figure 1 Bridge damaged by the earthquake of August 17, 1999

Collapse of Arifiye Overpass (Courtesy of H. Hoashi)

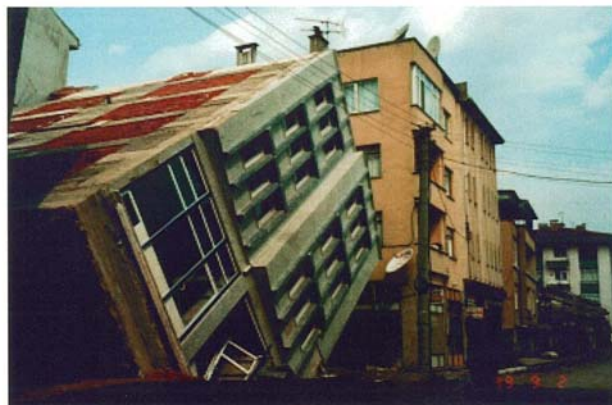
Figure 2 Building damaged by the earthquake of August 17, 1999

Toppled and collapsed buildings in T c lar district of Adapazar
