A Comprehensive Study on the Applicability of Japanese Dam Technologies to the Alarming Condition of Angat Dam in Bulacan, Philippines

> AMEERHA P. ORTEGA ADRC Visiting Researcher FY2014B

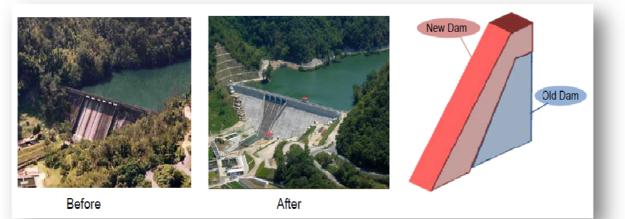
From Dam Technologies of Japan

One way of improving dam function is increasing reservoir volume under operation. The height of the dam can be raised under operation, to increase reservoir volume. To do this, the safety of the existing dam is assessed, ways to unify the old dam with the new construction are examined, and the stability of the foundation and the newly constructed dam extension is examined. Even old dams can be made higher following detailed and careful assessment.
