Lesson Learnt from Past Japanese Natural Disaster Experience

YUJIRO OGAWA

DEAN, DEPARTMENT OF ENVIRONMENT AND DISASTER RESEARCH
FUJI-TOKOHA-UNIVERSITY

MAIN EARTHQUAKE DISASTERS IN JAPAN

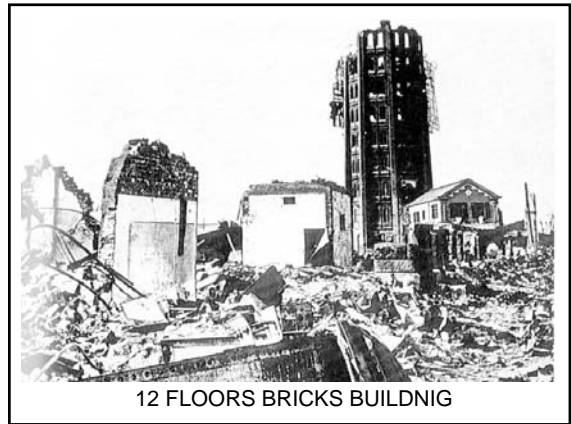
12 FLOORS BRICKS BUILDING

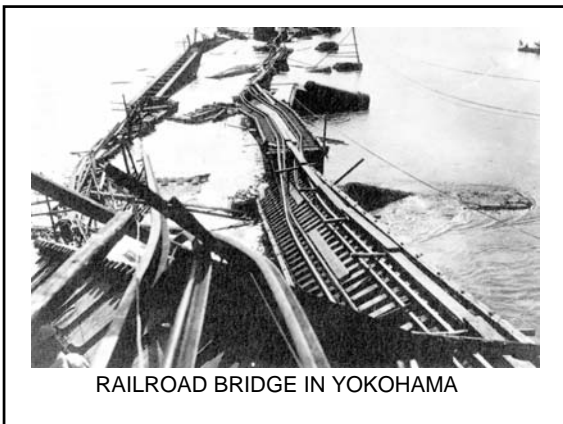
RAILROAD BRIDGE IN YOKOHAMA

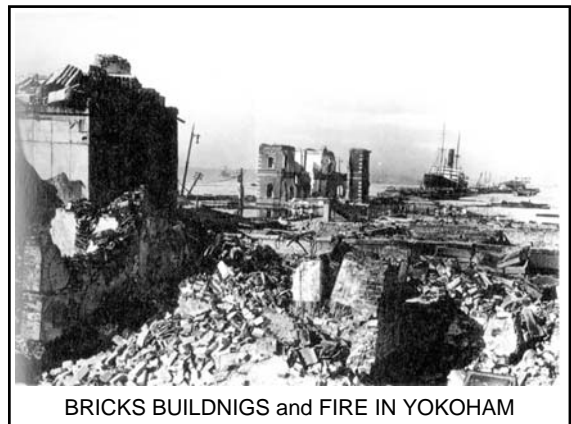
BRICKS BUILDINGS and FIRE IN YOKOHAMA

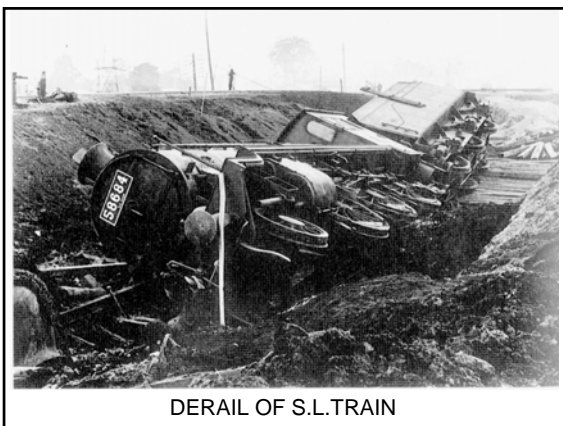
DERAIL OF S.L. TRAIN

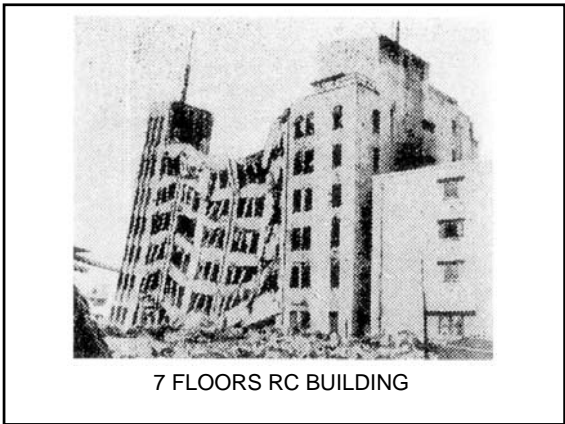
7 FLOORS RC BUILDING

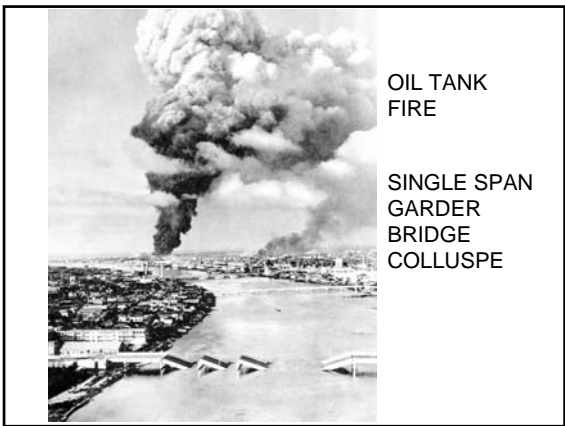
OIL TANK
 FIRE

SINGLE SPAN
 GARDER
 BRIDGE
 COLLUSPE

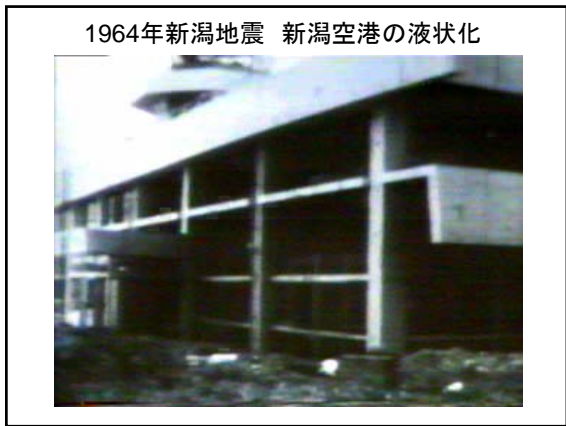
1964年新潟地震 新潟空港の液状化

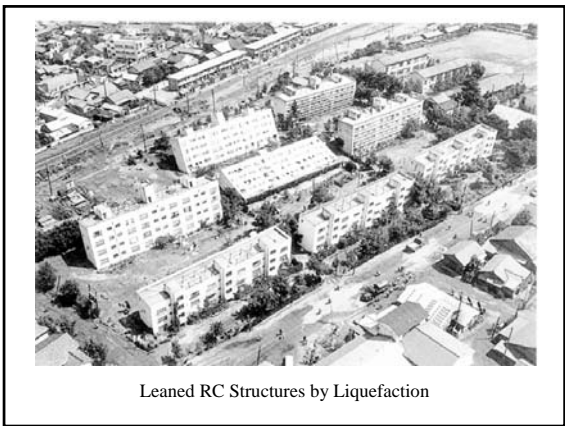
Leaned RC Structures by Liquefaction

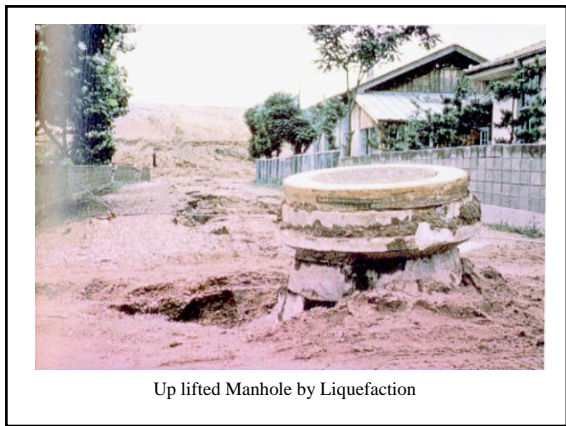
Up lifted Manhole by Liquefaction

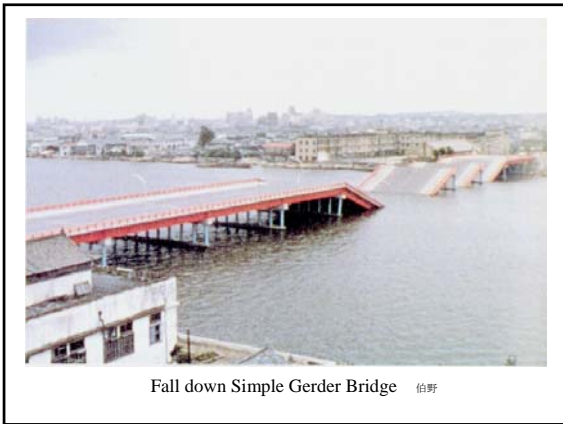
Fall down Simple Gerder Bridge 伯野

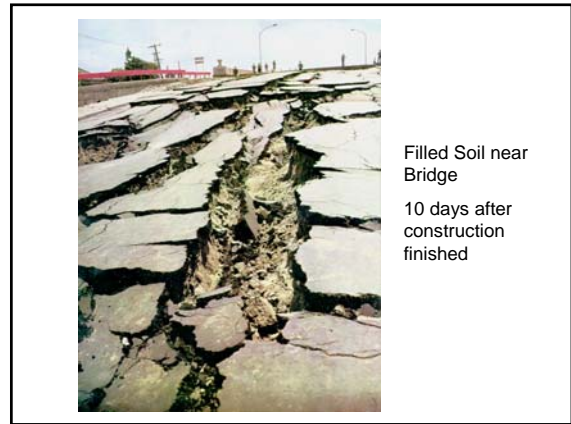
Filled Soil near Bridge
10 days after construction finished

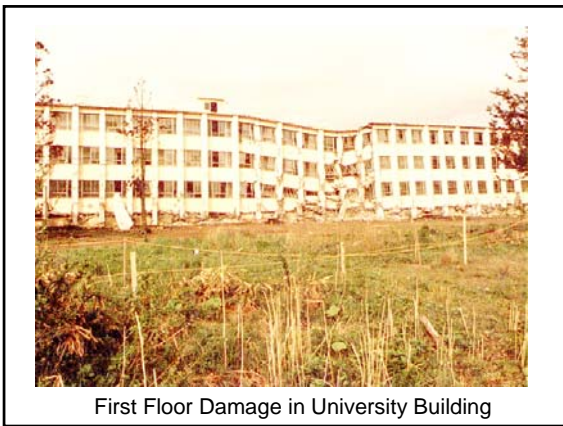
First Floor Damage in University Building

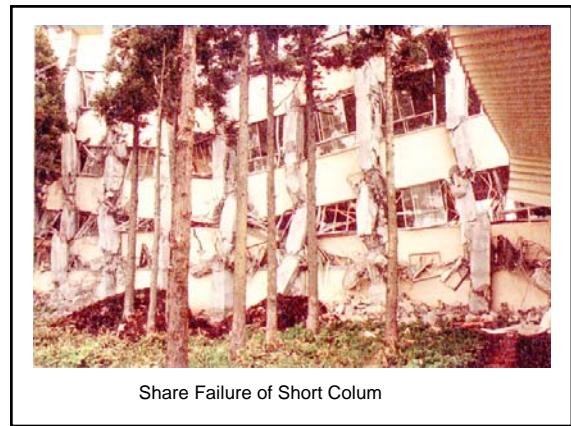
Share Failure of Short Colum

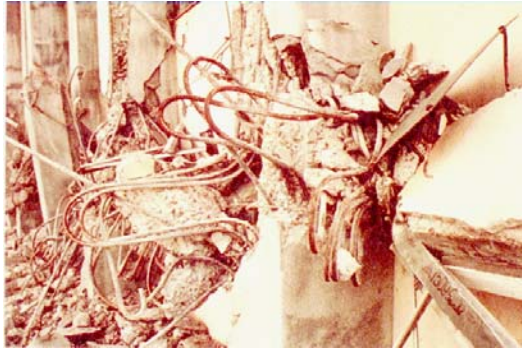
Compression Failure by Insufficient Star-lap

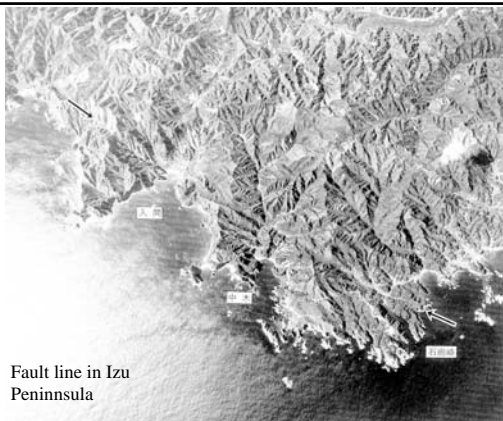
Fault line in Izu Peninsula

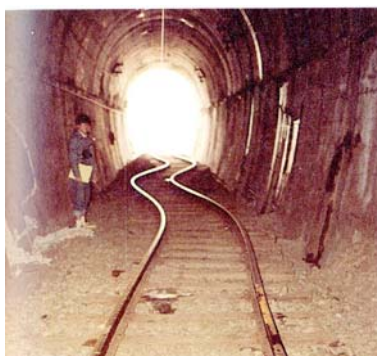
Railway Tunnel which Earthquake Fault passed

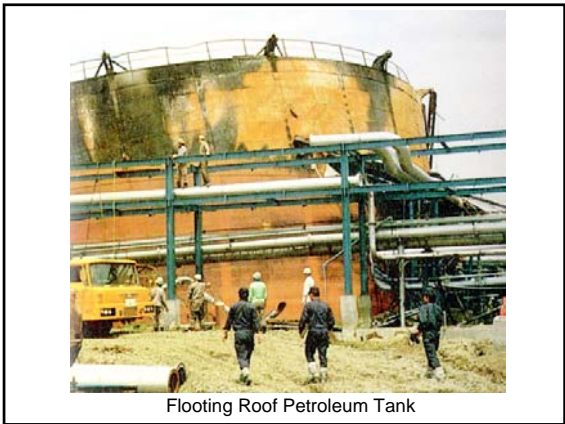
Floating Roof Petroleum Tank

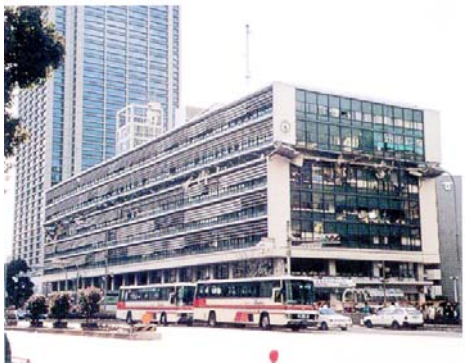
Collapse of Middle Floor

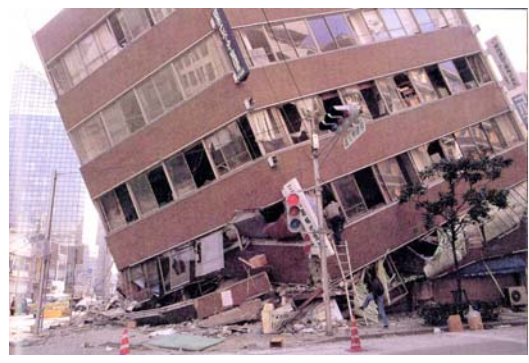
ピロティ形式構造の崩壊 朝日

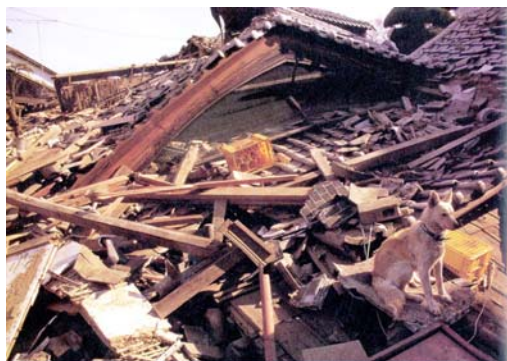
Japanese Style Houses (Heavy Roof)

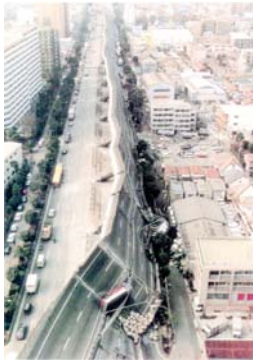
One Column Highway Bridge

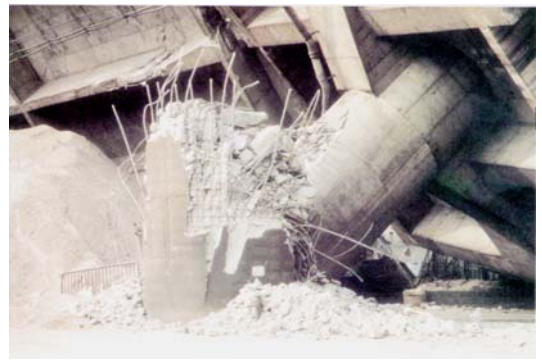
One Column Highway Bridge

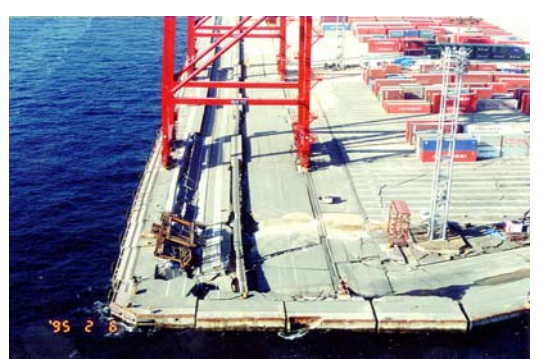
Side Slip of Pier

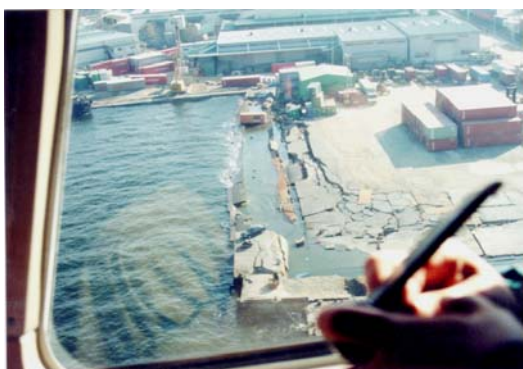
Side Slip of Pier

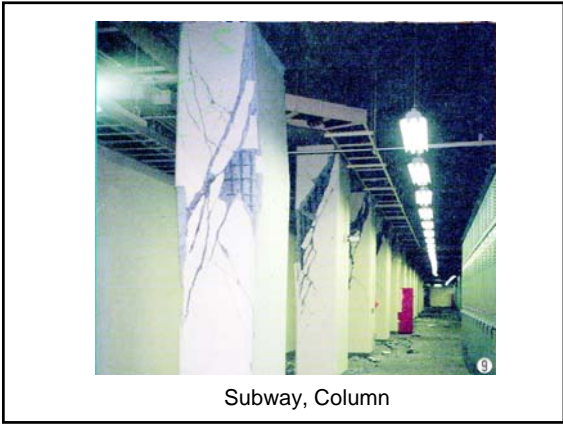
Subway, Column

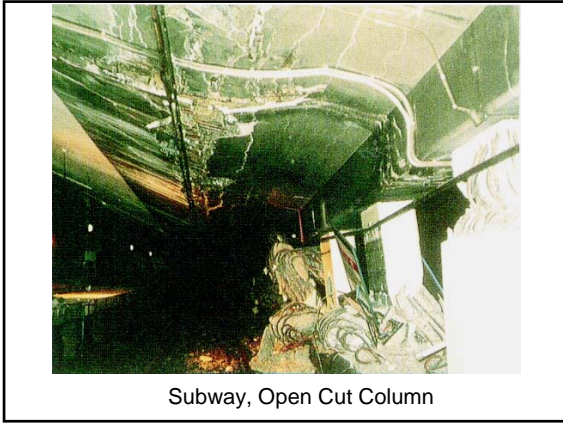
Subway, Open Cut Column
