6 Activities of Investigation on Disaster Damage in Asia

6-1 Field Survey on the Solomon Islands

Earthquake and Tsunami Investigation

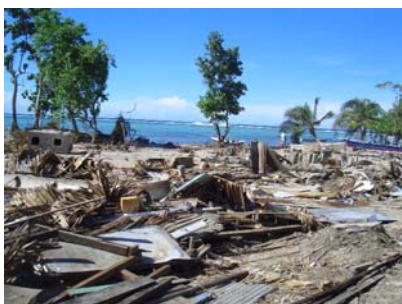
The team found that the largest tsunami attacked the western coast of Gizo Isl. (over 5 m at Malakerava) and the northern part of Simbo Isl. (around 8 m at Tapurai) about five minutes after the earthquake. Waves struck three times at intervals of a few minutes. The worst devastation was found in coastal villages, where houses were reduced to their foundations.
