Country Presentation – Sri Lanka

Dinesh Hemachandra
Scientist /Geologist
National Building Research Organisation
Ministry of Disaster Management
Sri Lanka
Visiting Researcher 2010 – ADRC, Kobe

Natural Disasters and Mitigation of Landslide hazard

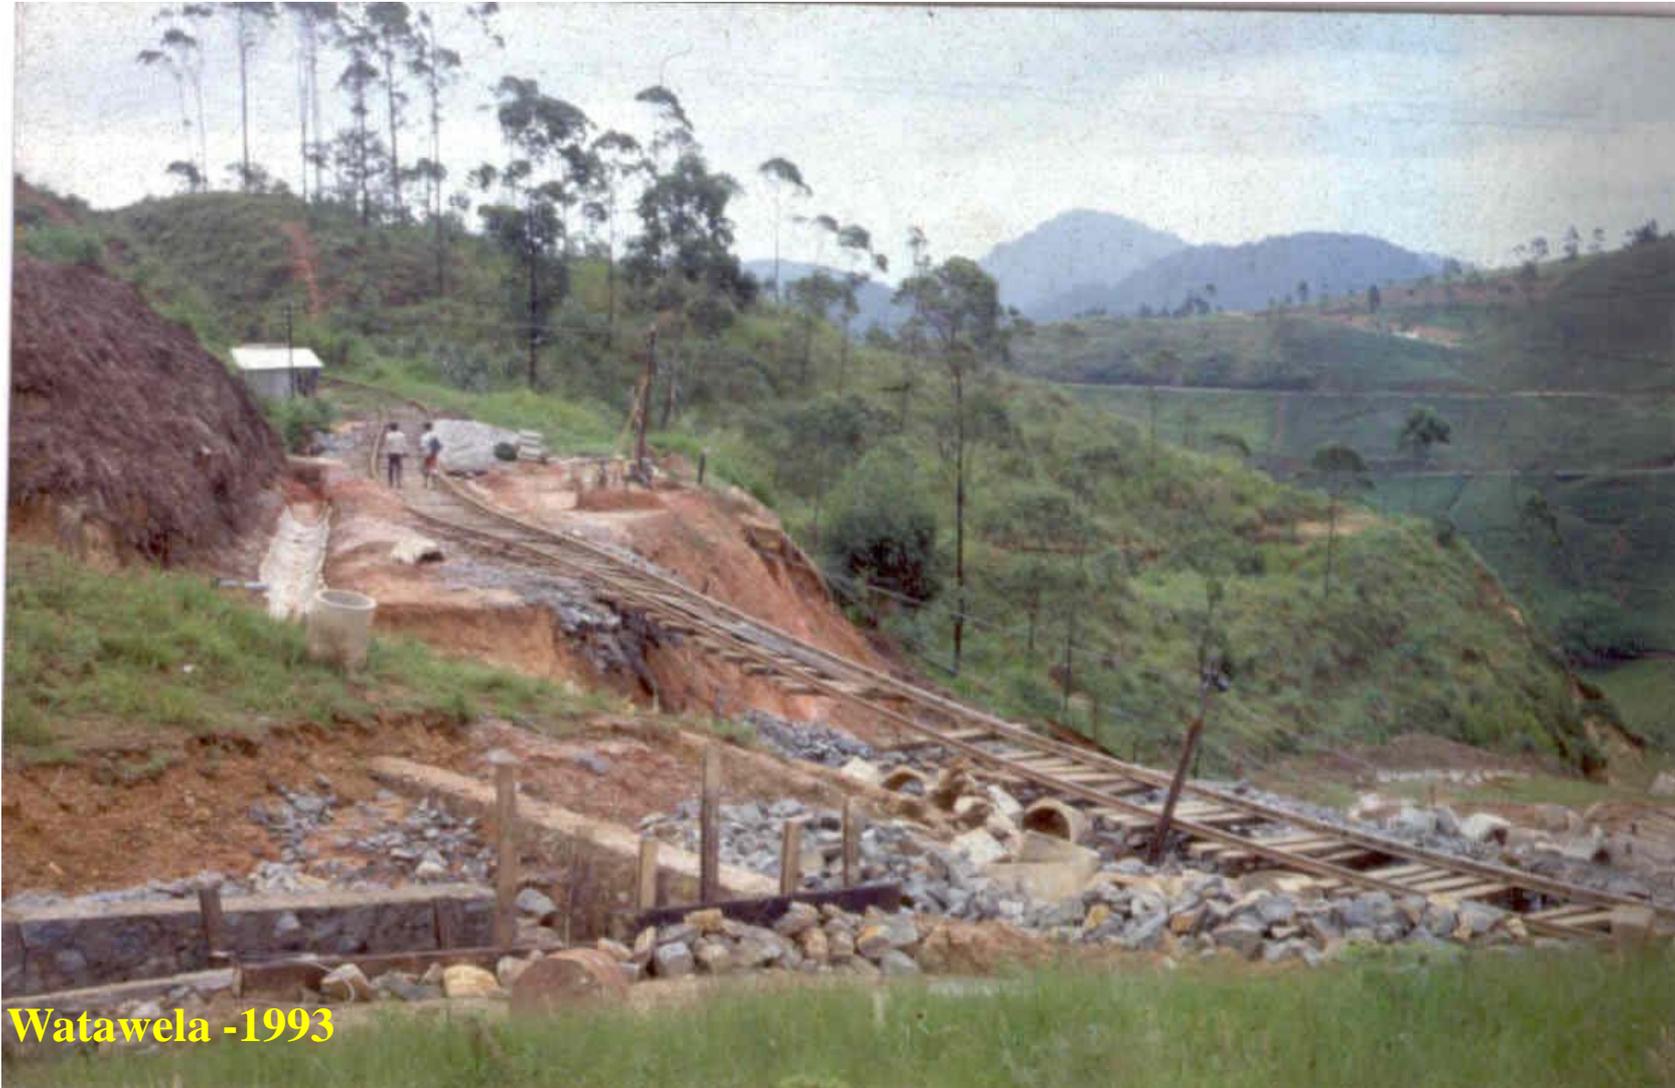
Mitigation of Watawala Landslide

Watawela -1992/1993

In Sri Lanka, most of landslides and cutting failures occur in the central highland of the country. The central region of Sri Lanka is hilly and mountainous with highly fractured and folded basement rock overlain by residual soil and colluviums.

Nuwara Eliya District – Landslide occurred 03rd June 1992

Lot of damaged made railway track and railway transport routing severely destructed

Rainfall about more than 200 mm

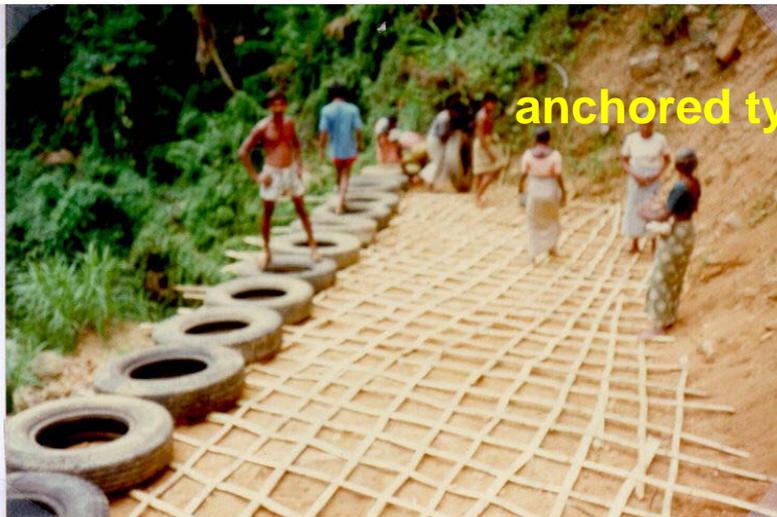
Construction of a diversion drain to a length of about 500m from culverts 2/3 to 1/13 for run off and stream water coming into the landslide area.

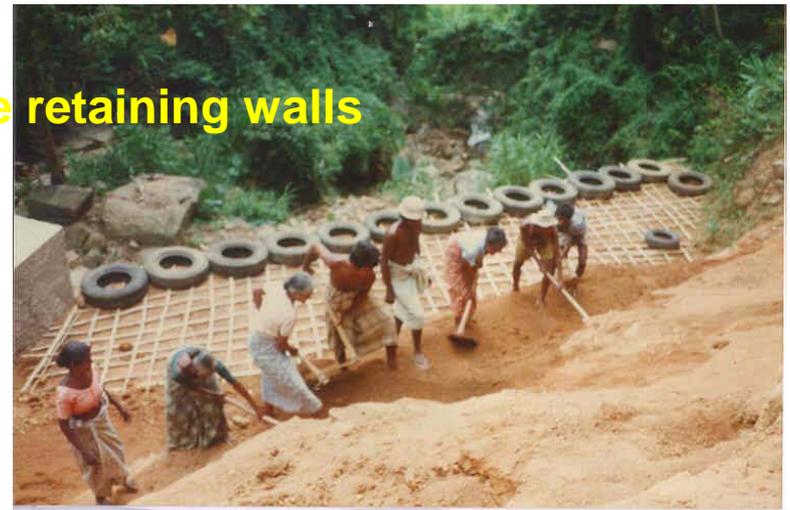
anchored tyre retaining walls

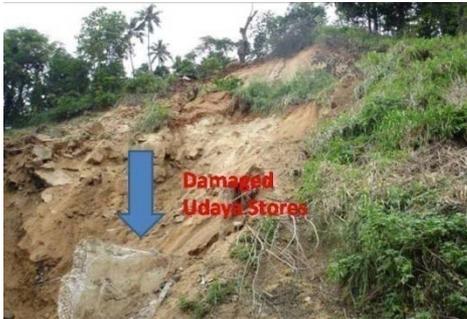
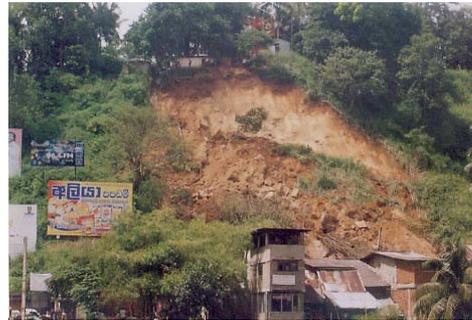
Kandy District- Peradeniya Landslide- 2006

With the heavy rainfall from 09th -11th November 2006,
A mass of soil and rock blocks failed at the upper slope of Peradeniya town 2006 at about 21:00 hrs night.

Due to this failure one shop (Udaya Stores) was completely damaged

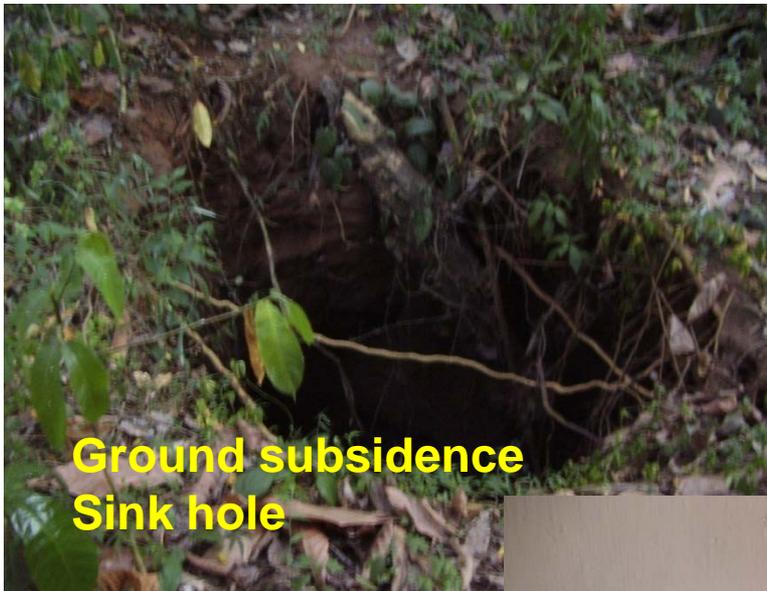
Land subsidence at Matale District

Investigation started 2006 ,
Prepared subsidence hazard
risk map

About 3000 affected houses
were identified within 24 Grama
Niladhari divisions of Matale

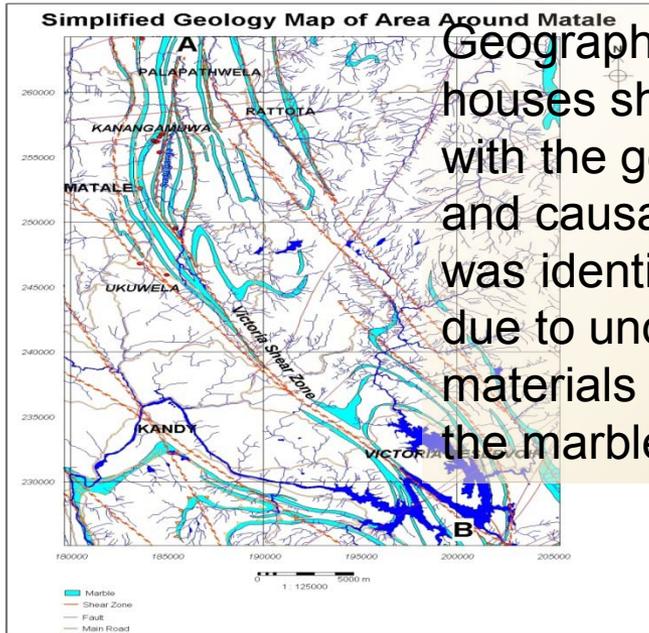
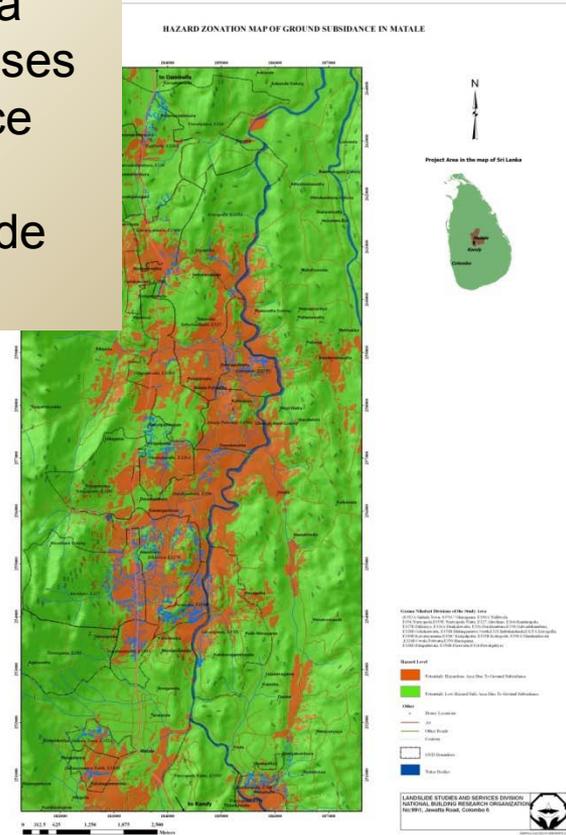
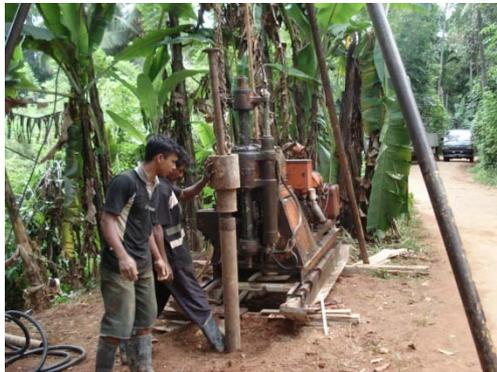
Geographical distribution of cracked houses showed an obvious relationship with the geological condition of the area and causative factor to cracking of houses was identified as the ground subsidence due to underground erosion of silty materials of the soil to the caverns inside the marble rock of the area

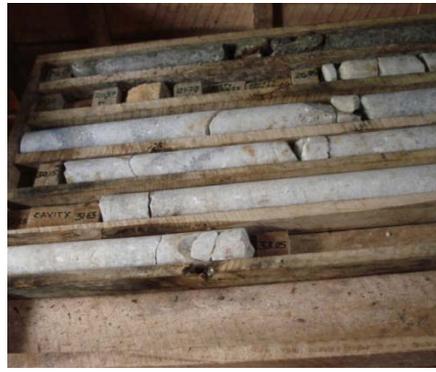
Drilling

Bore hole logging

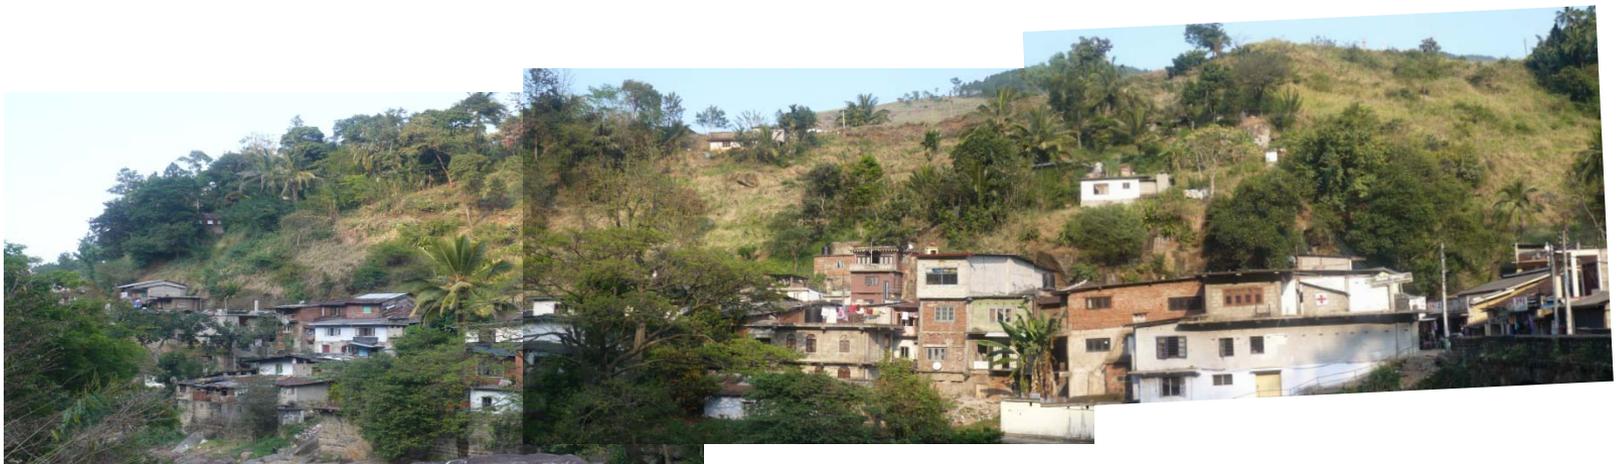
NBRO was started Padiyapalella landslide mitigation - 2009

Photograph showing an aerial view of Padiyapelella town with its unstable slope, after site cleaning

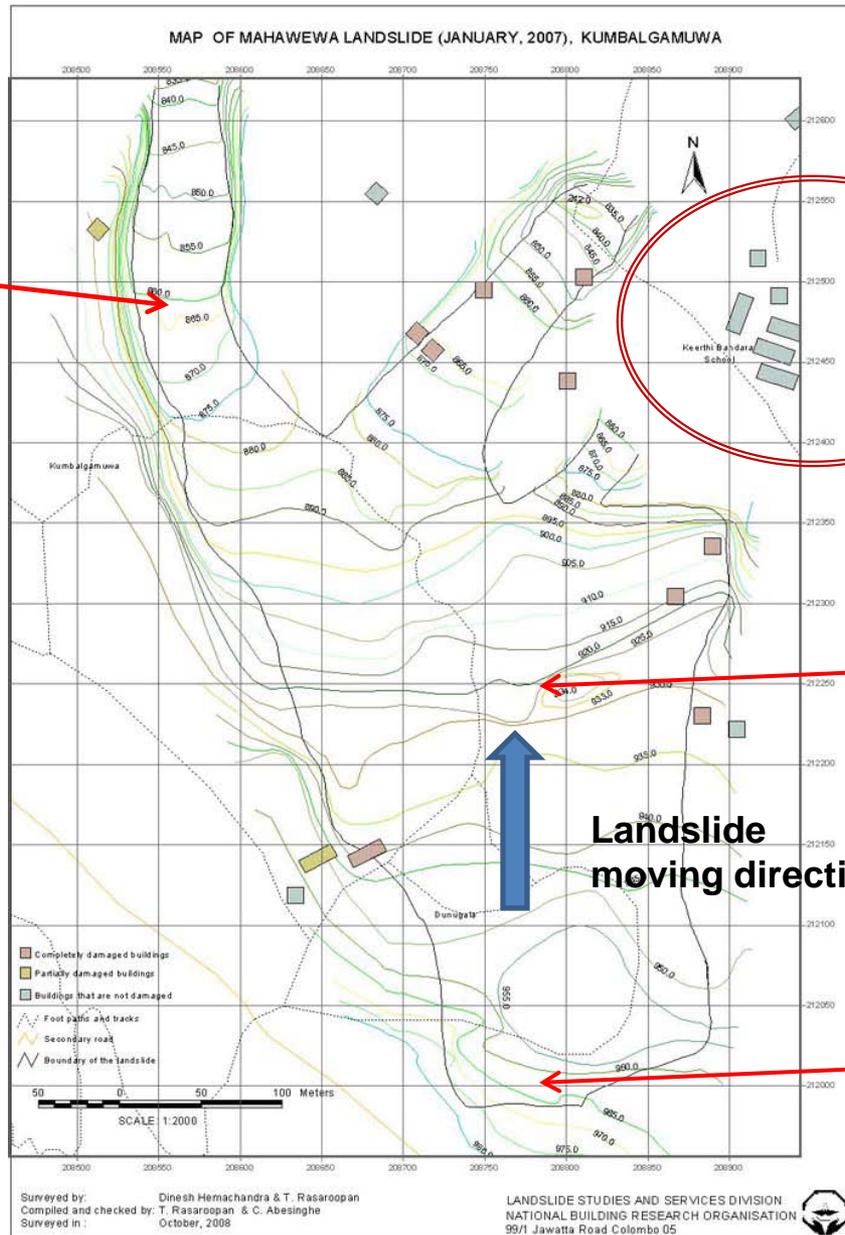
MAP OF MAHAWEWA LANDSLIDE (JANUARY, 2007), KUMBALGAMUWA

Toe area of the landslide

Landslide moving direction

Head of the landslide

At present, the project area has been mapped for its topographical and geological details.

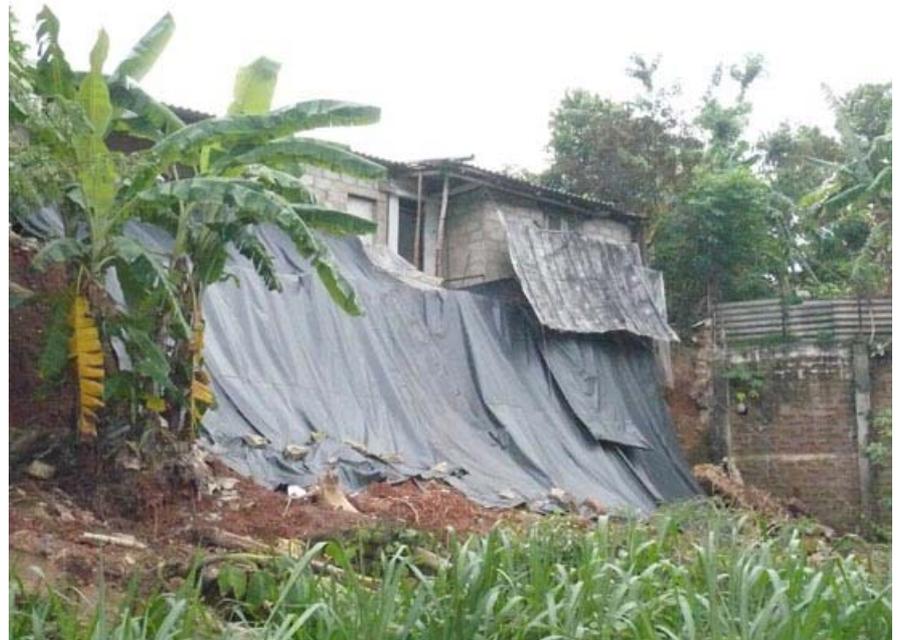
Technical report submitted to clients and guided how to construct gabion wall to protect future failure

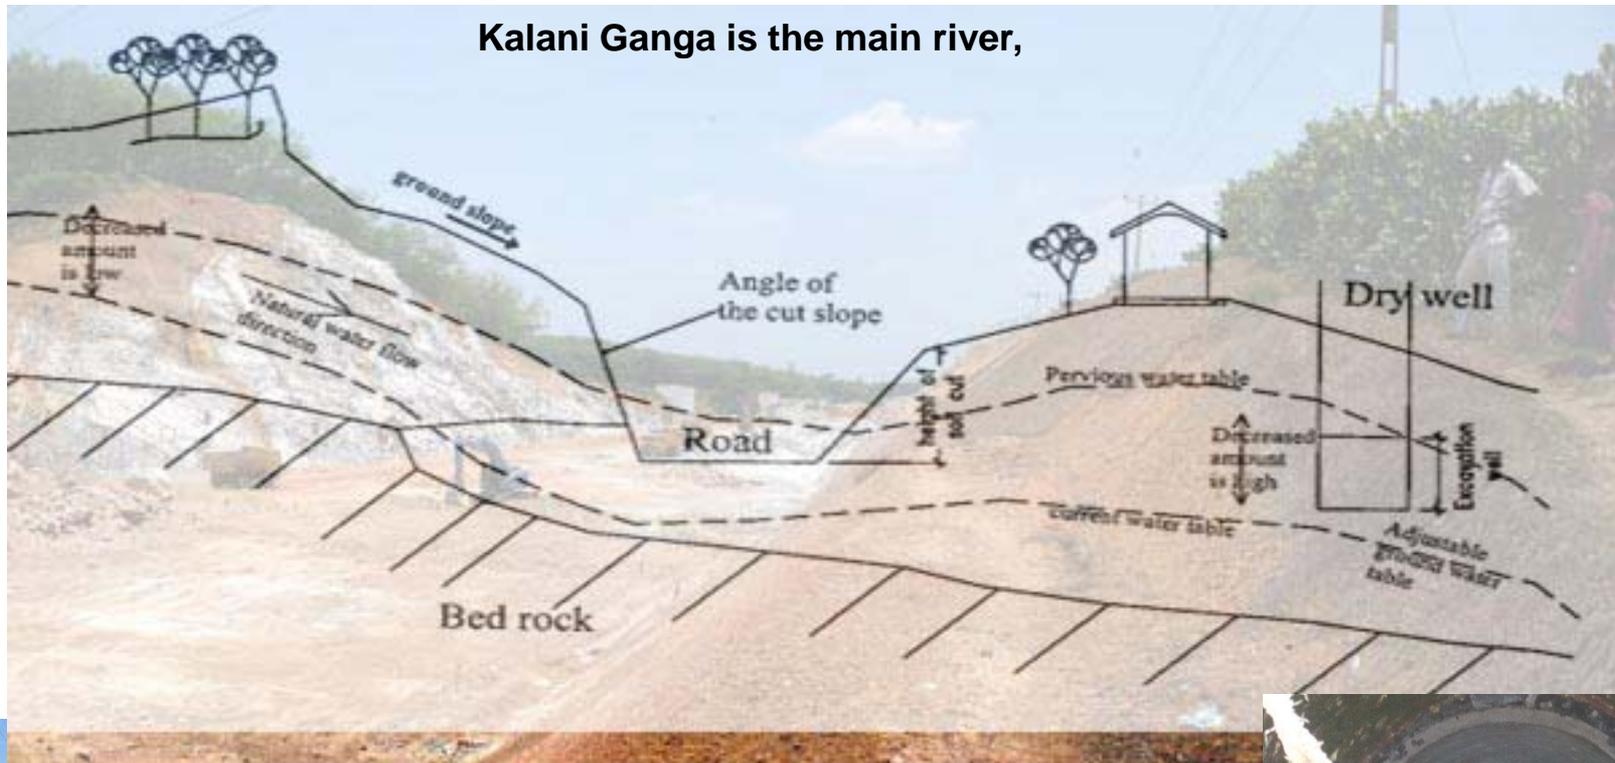
Determine the impact of rock blasting / excavation on the observed depletion of ground water table - 2010

study areas are situated in the wet zone of Sri Lanka.

Geomorphology of the study area,

Kalani Ganga is the main river,
