# 2025 マンダレー地震 (ミャンマー) (GLIDE No. EQ-2025-000043-MMR)

2025年3月28日12:50(MMT, UTC+6:30, 日本時間15:20)、ミャンマー中部ザガイン地区でマグニチュード7.7の地震が発生した(GLIDE No. EQ-2025-000043-MMR)。震源地は同国二番目の都市マンダレー近郊で、震源の深さは約10kmと推定されている。震源地付近の最大震度は9(修正メルカリ震度)を記録した。これは1912年5月23日に発生したメイミョー地震(マグニチュード7.9)以来最大の地震である。

# 被害状況 (as of 18:00 on 21 APRIL 2025)

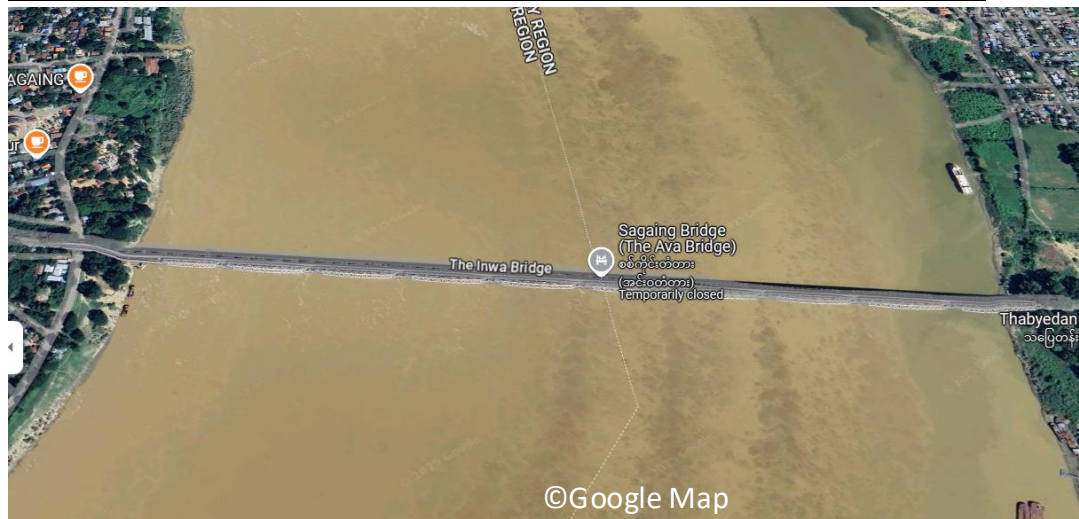
# Comparison of the Inwa Bridge in Mandalay, before and after the disaster

Satellite imagery from Strix Satellite of Synspective, showed the collapsed Inwa (Ava) bridge in Mandalay.

On March 28th, 2025, a 7.7-magnitude earthquake struck the Sagaing Region of Myanmar. Synspective StriX Satellite captured the Collapsed Ava Bridge in Mandalay.

Observation Date: 2025-03-28 21:15:55 UTC

Observation Mode: Staring Spotlight Mode (0.9m x 0.25m resolution)

| 日付 | 標準時<br>(UTC) | 日本<br>(JST) | ミャンマー<br>(MMT) | 地震発生と対応 |
|---|---|---|---|---|
| | 21:15 | 6:15 | 3:45 | SynspectiveがSAR衛星でMandalayの橋の破損を観測 |

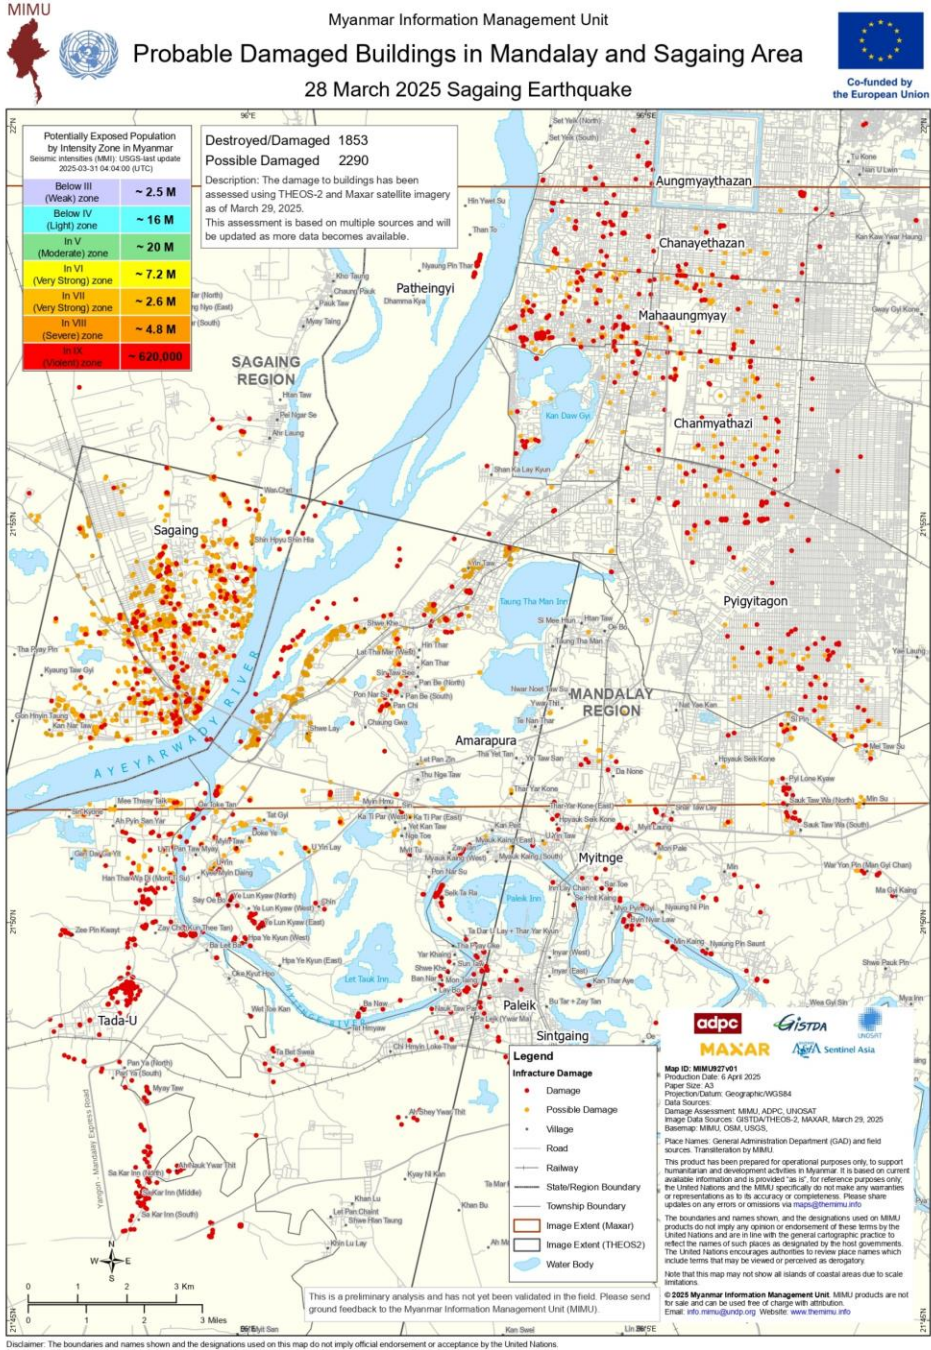
# Probable Damaged Buildings in Mandalay and Sagaing Area is provided by MIMU. Destroyed/Damaged 1,853 Possible Damaged 2,290

The damage to buildings has been assessed using THEOS-2 and Maxar satellite imagery as of March 29, 2025.

This assessment is based on multiple sources and will be updated as more data becomes available.
