Experimental Validation-Based Vulnerability Assessment and Mitigation Method Development for Mass-movement Disaster

National Disaster Management
Research Institute

Geotechnical Disaster
Experiment & Research Team Leader
Jae-Jung, Kim

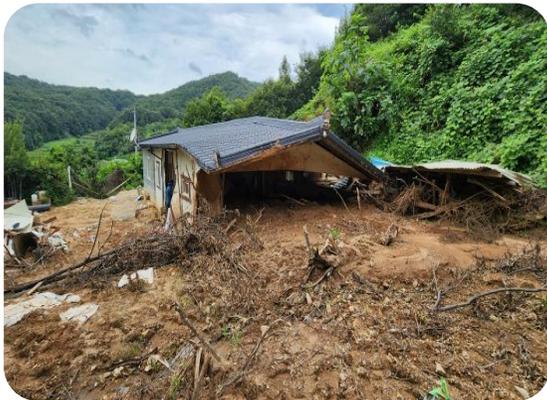
< Wooden structures >

▣ Collapse Type and Damage Characteristics of Building

- » Collapse of buildings due to concentrated impact on the lower structure (collapse area expands upward)
- » Severe damage in management blind spots; difficult to predict
- » Openings in RC-frame structures are vulnerable

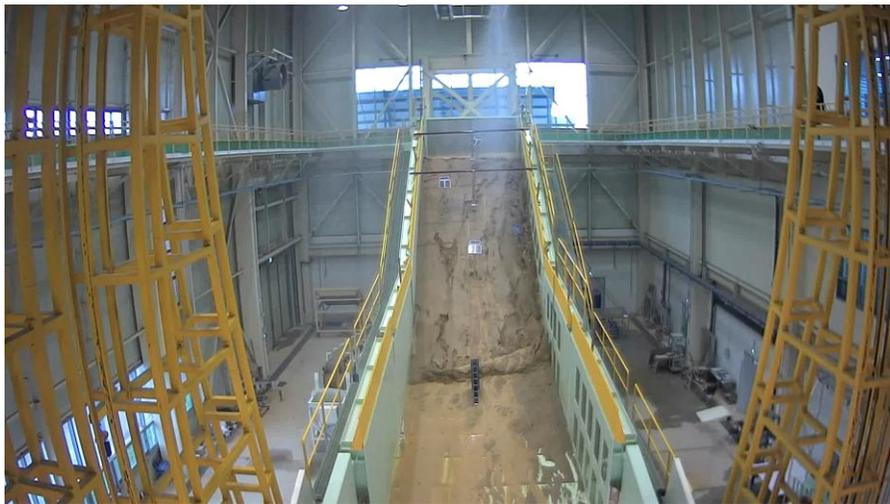
Before improvement('21):
Inclined sand layer not applied
⇒ Collapse Velocity **1m/s**

⇒ Satisfied the range (4–5 m/s) known to cause building damage in prior studies (Cui et al., 2005)

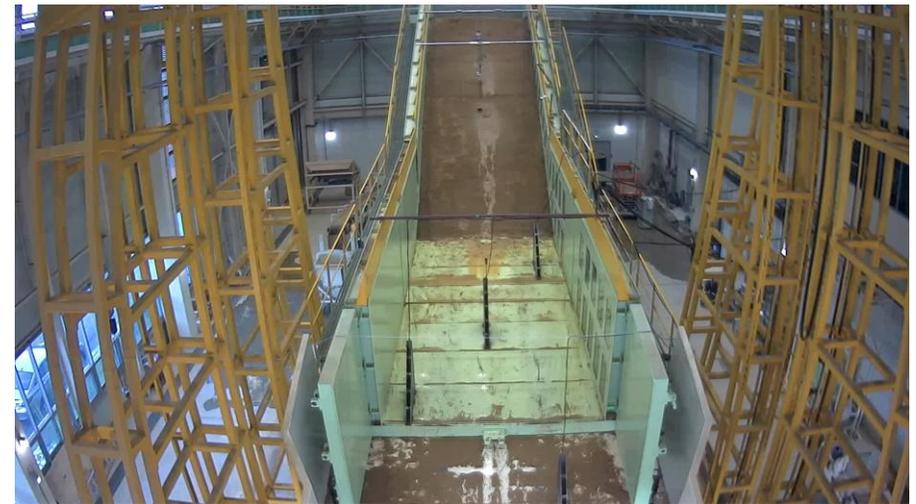
After improvement('23):
Inclined sand layer applied
⇒ Collapse Velocity **4~5m/s**

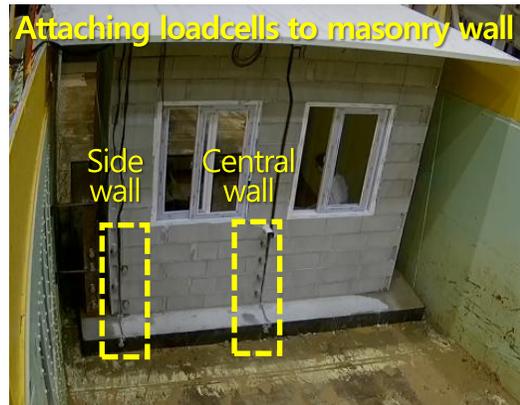
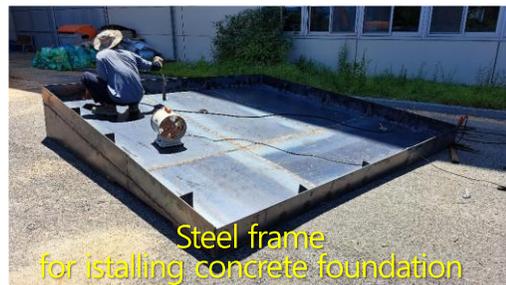
Vulnerability Test for Masonry Buildings

- » Installed a steel frame with a concrete foundation, Inclined sand layer
- » Load cells were installed on central and side walls, as well as on the indoor floor center

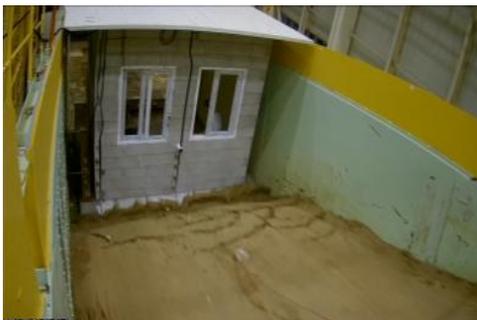
Contacting foundation

» Collapse sequence : Central wall → side walls → ceiling (collapsing inward)

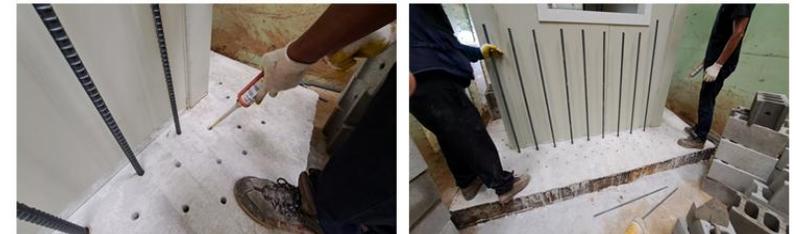
- For vulnerable panel-type buildings, applied a “reinforced masonry attachment method (structural reinforcement)” + “window shutter installation (protective measure)”
 - Economic feasibility: Approx. 250,000 JPY for installation of 1.2 m height × 10 m length wall
 - Constructability: Can be installed in mountainous areas where ready-mix trucks cannot enter

Inserted longitudinal reinforcement into the foundation

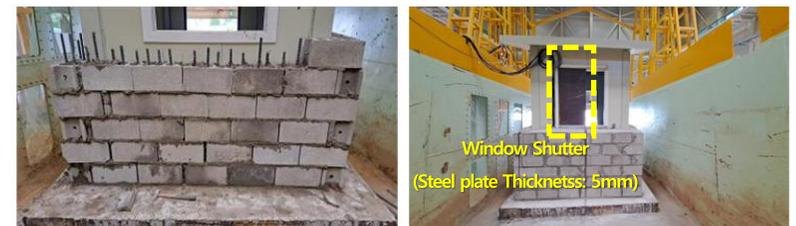
Injected mortar into the brick voids

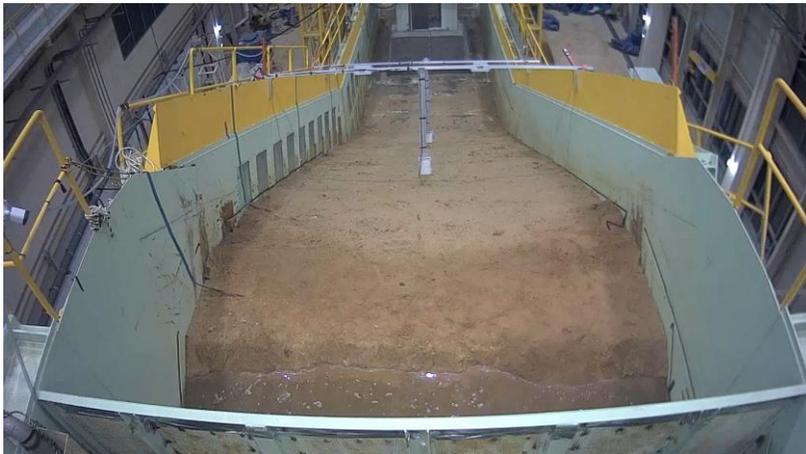
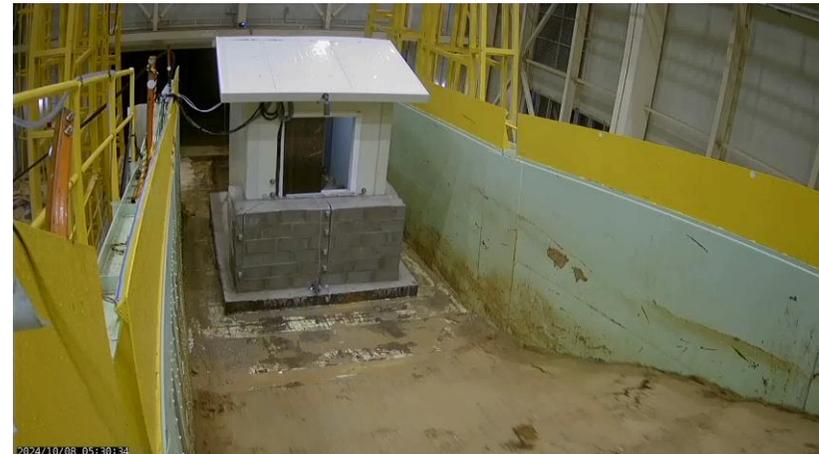
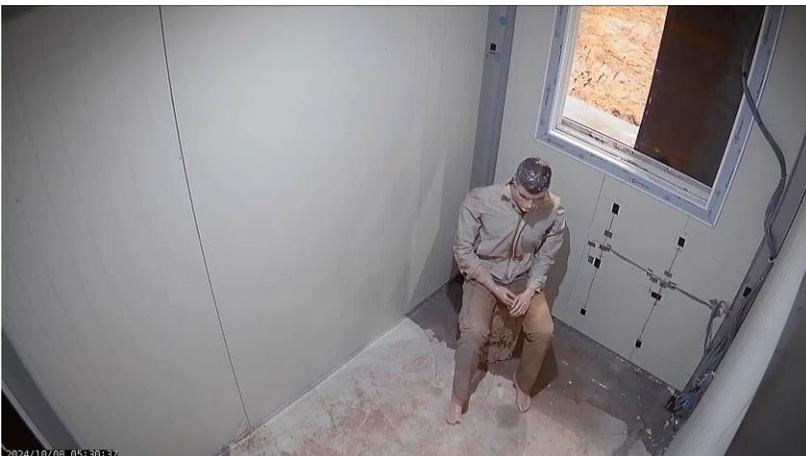
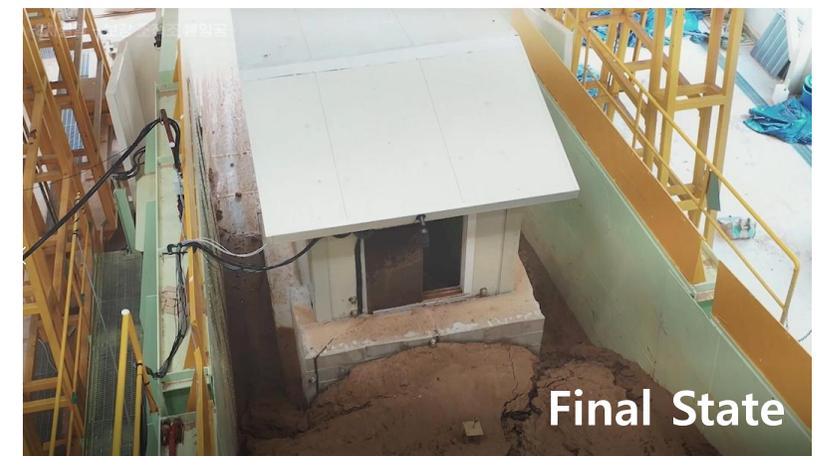
Effectiveness Verification Experiment

- ✓ Panel buildings reinforced with masonry attachment showed only minor damage
- ✓ No soil inflow observed in sections protected by window shutters

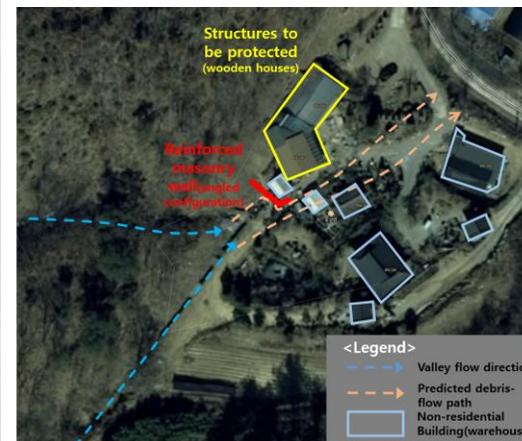
Reinforced masonry retaining wall

- Installed reinforced retaining walls (masonry blocks + longitudinal/transverse rebar + mortar) in front of wooden houses located in predicted debris-flow zones

Vulnerability: 100 Score(Very vulnerable grade)

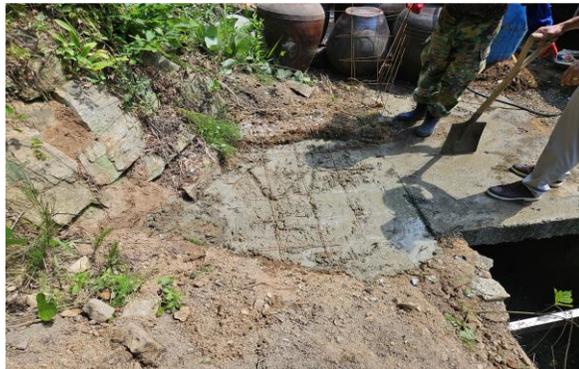
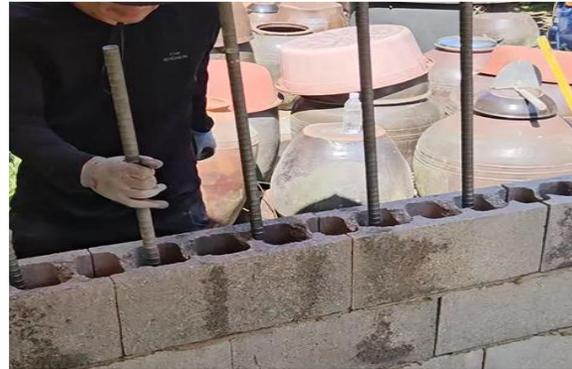
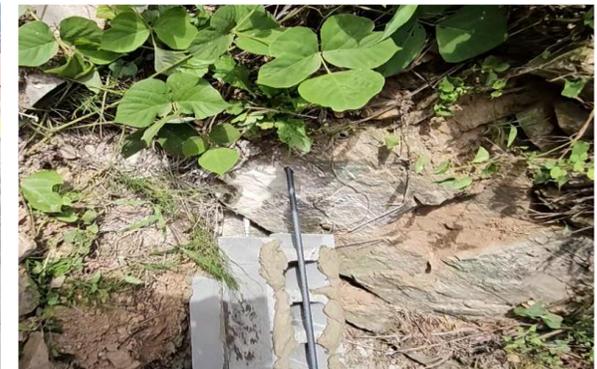
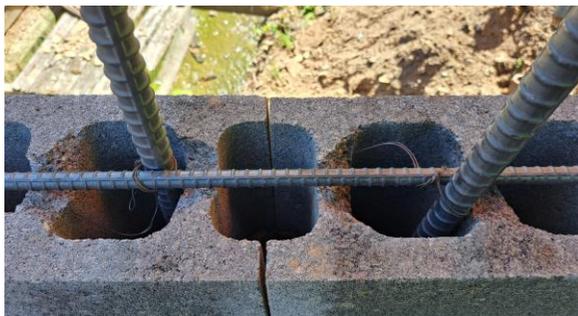
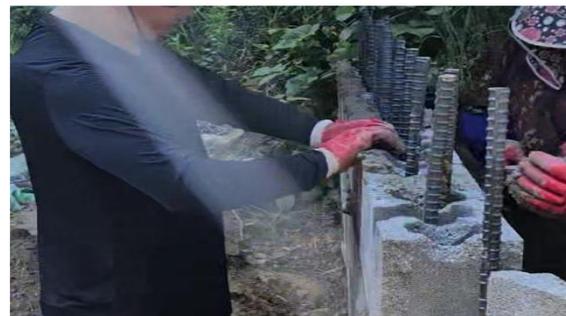
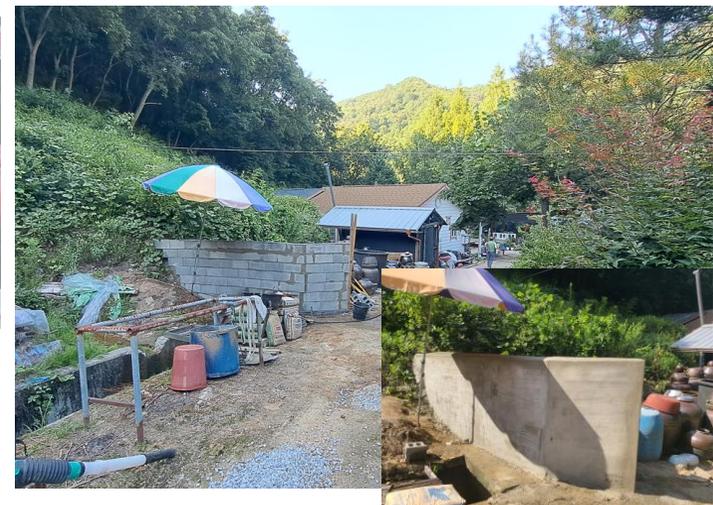
Reinforced masonry retaining wall

- » Installed reinforced retaining walls (masonry blocks + longitudinal/transverse rebar + mortar) in front of wooden houses located in predicted debris-flow zones

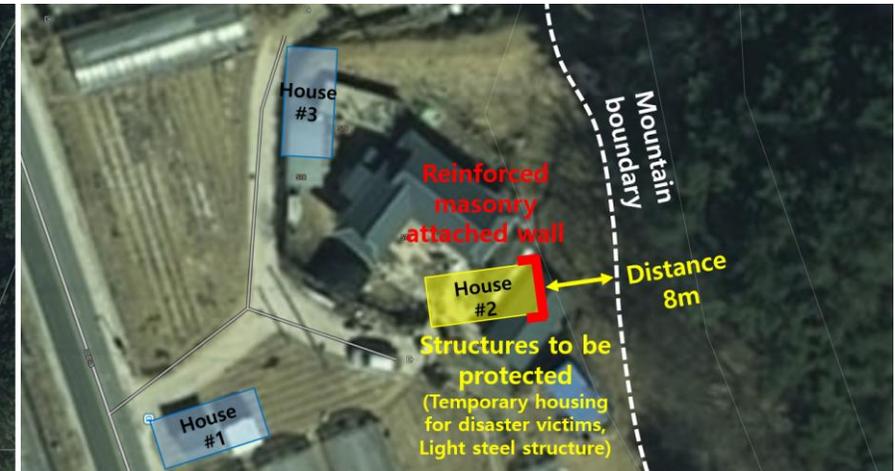
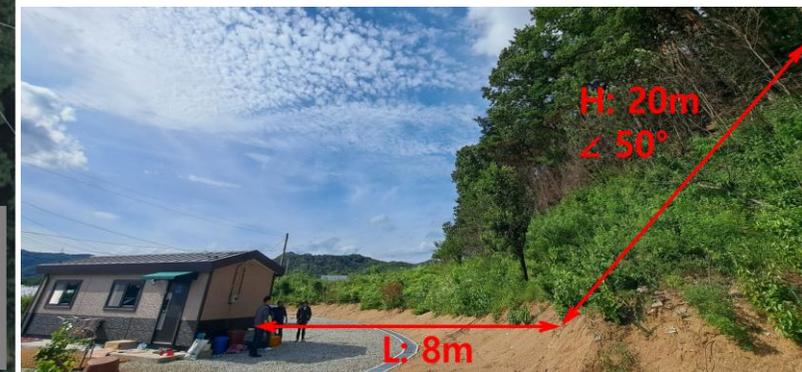
Reinforced masonry attached wall(Steep Slope in Wildfire-affected area)

- Temporary residential structures (light steel frames) located 8 m from the mountain boundary (approx. 0.4 H of slope height) — highly vulnerable

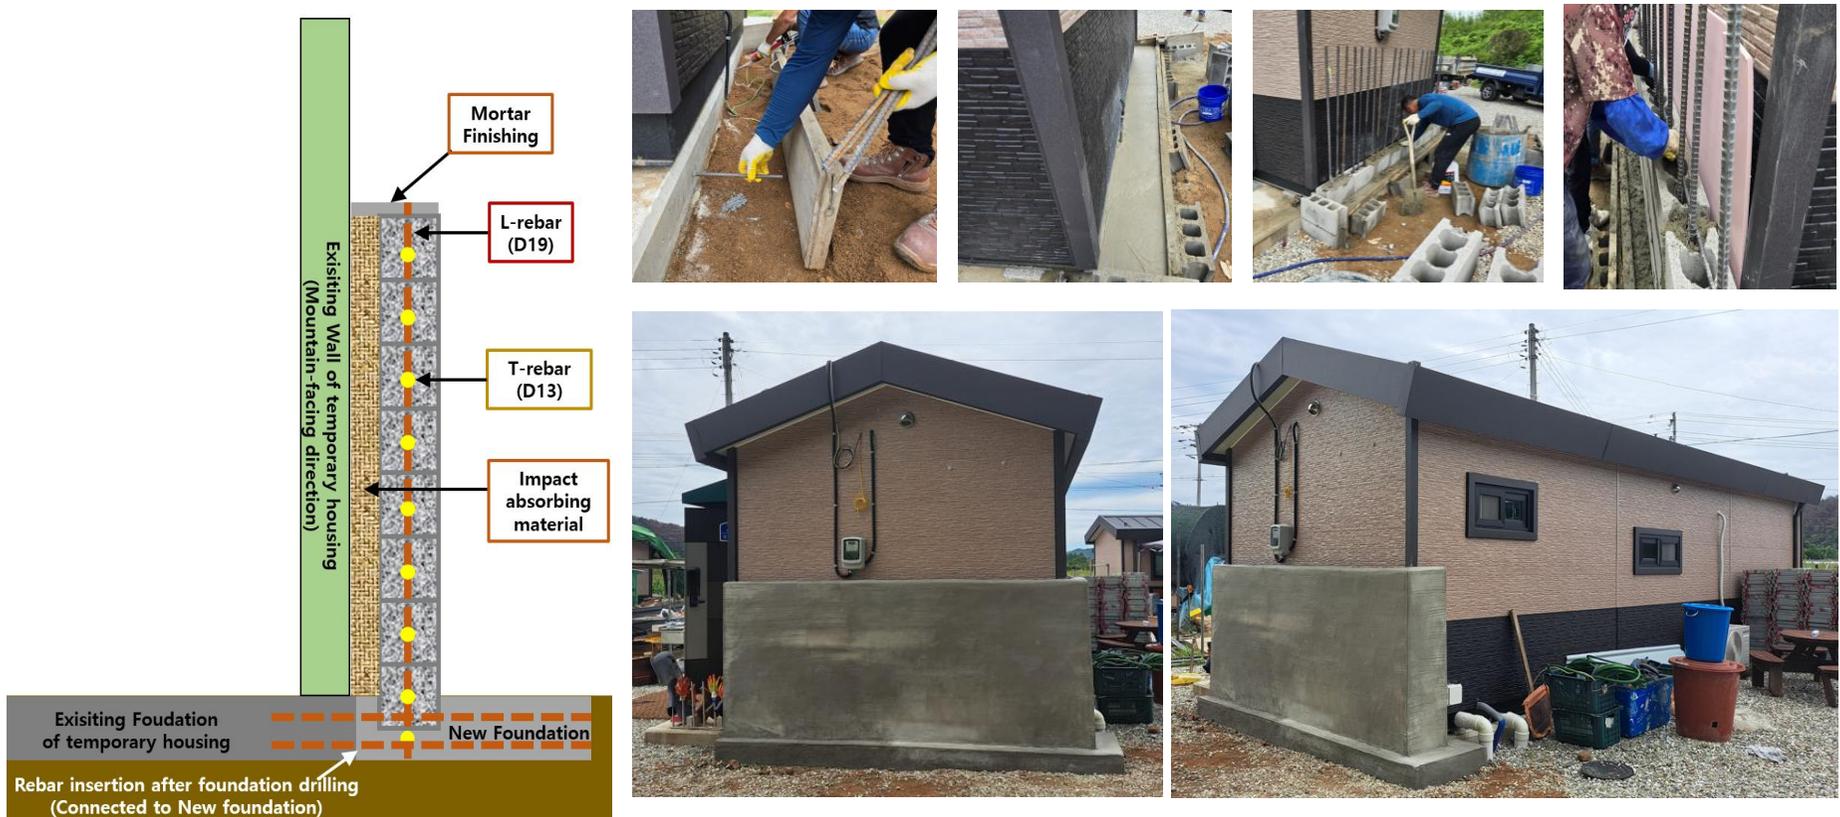
Reinforced masonry attached wall(Steep Slope in Wildfire-affected area)

- On the mountain-facing wall of the temporary housing, applied "masonry blocks + longitudinal/transverse rebar + mortar + impact-absorbing material."
