5. Activities of Investigation on Disaster Damage in Asia

5-1. Investigation on Disaster of Jawa Earthquake in Indonesia

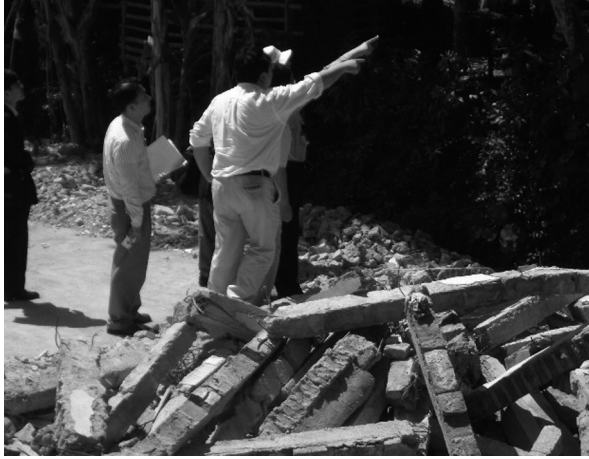
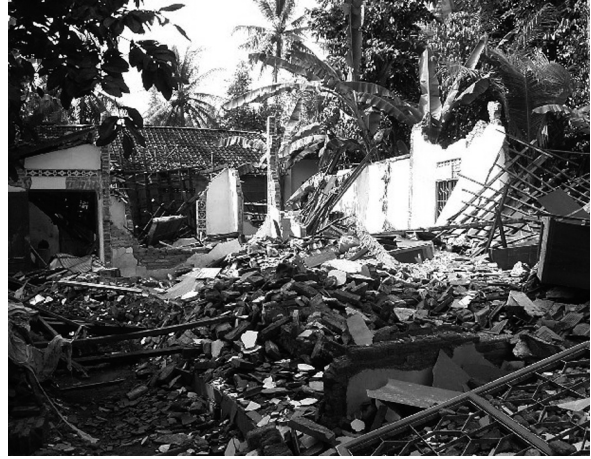
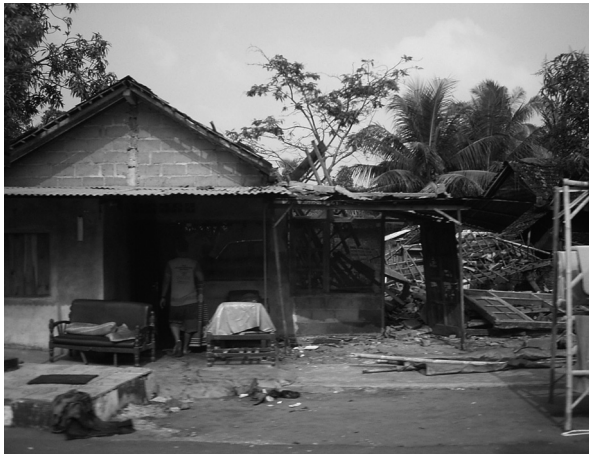
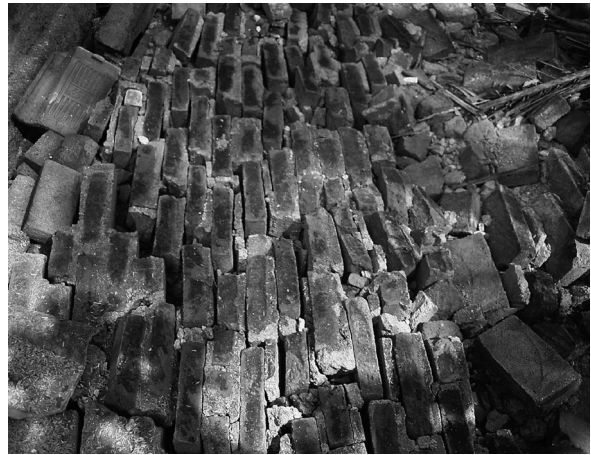
We dispatched inspectors at a relatively early stage and investigated activities in the disaster-hit areas starting from disaster-relief stages. The reason for causing a lot of casualties for its seismic scale (M6.3) is that most of them were buried under the fallen houses. Most of such fallen houses were structured with frames of reinforced concrete and walls of sun-dried bricks. Regarding the frames of reinforced concrete, their reinforcing bars were thin, amount used was small, wrapping around the connections was insufficient, and the transverse reinforcement was also insufficient. Some concretes only had strength that they are peeled off in pieces when scraped with a fingernail. In addition,

walls made of sun-dry bricks are structurally weak, easy to be fallen, and if they fall down, they could cause very dangerous situation because they are very heavy. These houses are built by residents themselves, and it is assumed that they did not have professional knowledge.
