# 2025 Mandalay Earthquake (Myanmar)

## (GLIDE No. EQ-2025-000043-MMR)

On 28 March 2025, 12:50(MMT, UTC+6:30)(15:20JST), an earthquake with a magnitude of 7.7 occurred in the Sagaing region of central Myanmar (GLIDE No. EQ-2025-000043-MMR). The hypocenter was near Mandalay, the country's second-largest city, and the depth of the epicenter is around 10 km. The maximum seismic intensity was IX on the MMI. This is the largest earthquake since the Maymyo earthquake (magnitude 7.9) on 23 May 1912. Significant damage has been reported in both Myanmar and Thailand. In Myanmar, a state of emergency was declared in six states and regions, including Sagaing region. A state of emergency was also declared in Bangkok, where seismic damage tends to be severe due to geological factors. As the secretariat of Sentinel Asia, which promotes the use of satellites for disaster management, ADRC contacted relevant organisations and requested emergency satellite observation.

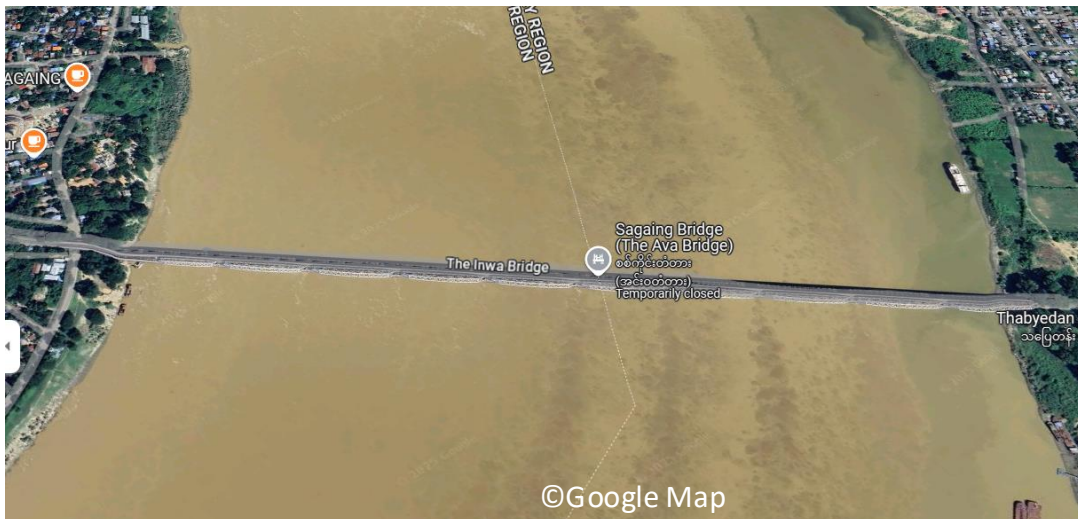
Satellite imagery from Strix Satellite of Synspective, showed the collapsed Inwa (Ava) bridge in Mandalay.

On March 28th, 2025, a 7.7-magnitude earthquake struck the Sagaing Region of Myanmar. Synspective StriX Satellite captured the Collapsed Ava Bridge in Mandalay.

Observation Mode: Staring Spotlight Mode (0.9m x 0.25m resolution)

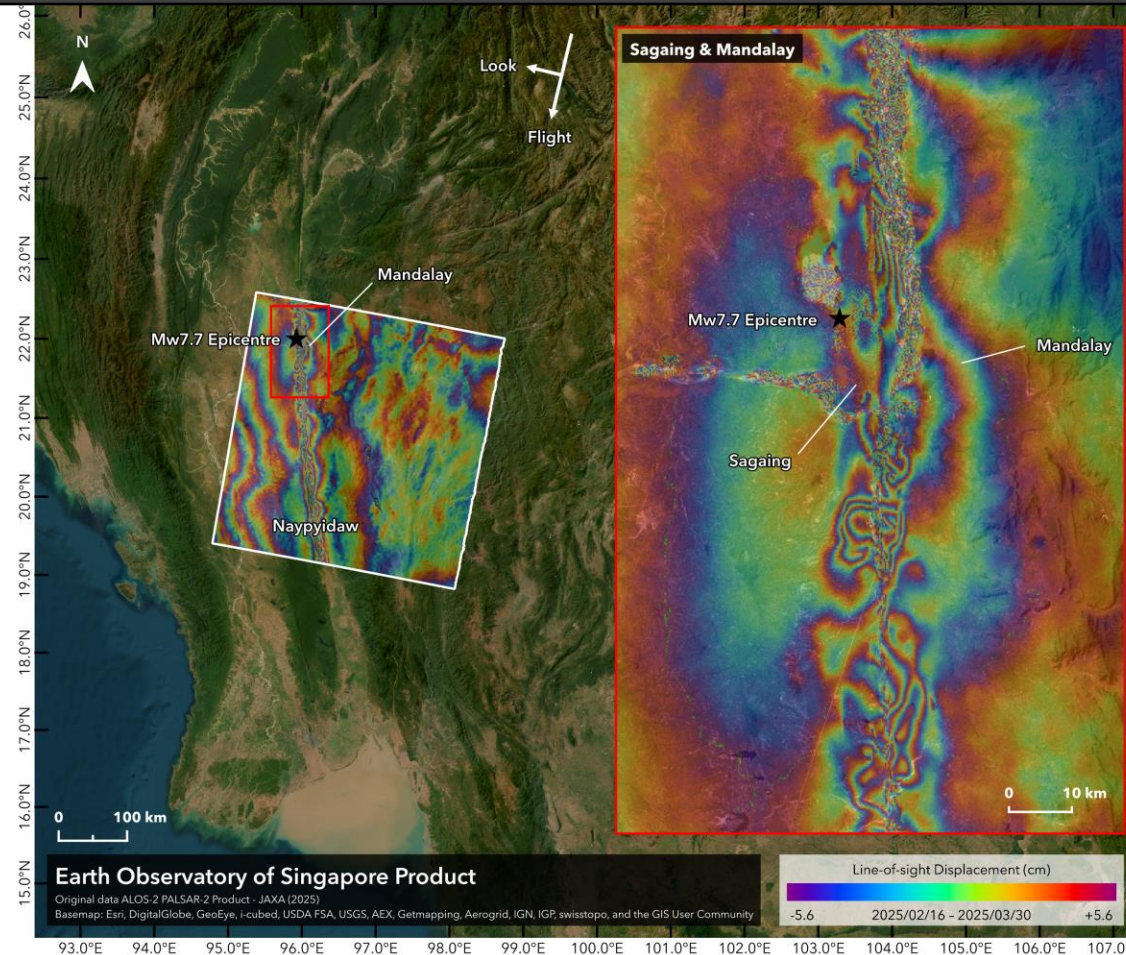
EOS-RS Interferogram (Wrapped): Myanmar, Earthquakes, 2025/02/16-2025/03/30, v0.1

The Earth Observatory of Singapore - Remote Sensing Lab (EOS-RS) created this Interferometric Synthetic Aperture Radar (InSAR) map that shows the surface displacement (wrapped interferogram) of the Mw7.7 earthquake and its aftershocks along the Sagaing Fault in Myanmar on 28 Mar 2025. This map was derived from SAR images acquired by the ALOS-2 satellite operated by the Japan Aerospace Exploration Agency (JAXA) before (16 Feb 2025) and after (30 Mar 2025) the event.

Each color cycle represents 11.2 cm of ground displacement in the radar line-of-sight. Ionospheric delay variation was mitigated, but tropospheric delay variation was not.

Earth Observatory of Singapore - Remote Sensing Lab (EOS-RS) created Interferometric Synthetic Aperture Radar (InSAR) map that shows the surface displacement (wrapped interferogram) of the Mw7.7 earthquake and its aftershocks along the Sagaing Fault

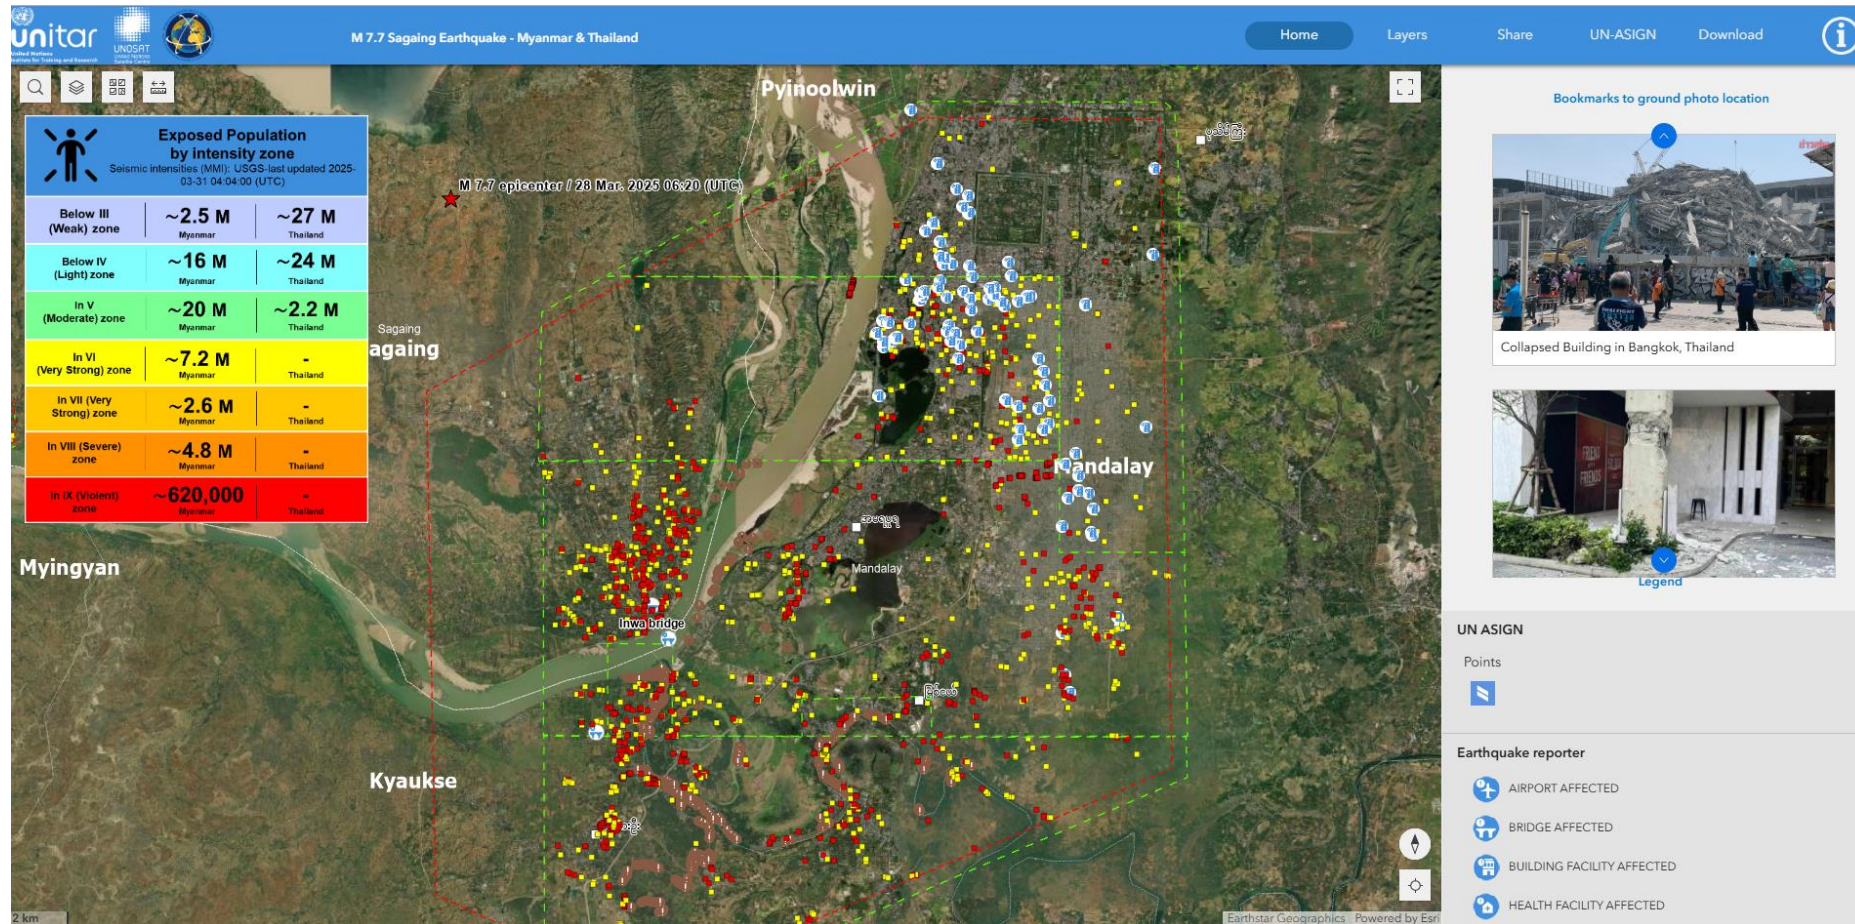
This map illustrates the potentially damaged structures/buildings. The analysis focuses on a part of Sagaing Township, Sagaing District, Sagaing Region, where damage was detected using a Pleiades very high-resolution satellite image acquired on March 30, 2025, at 11:01 local time. UNOSAT identified 233 damaged structures and 557 potentially damaged ones. This is a preliminary analysis and has not yet been validated in the field.

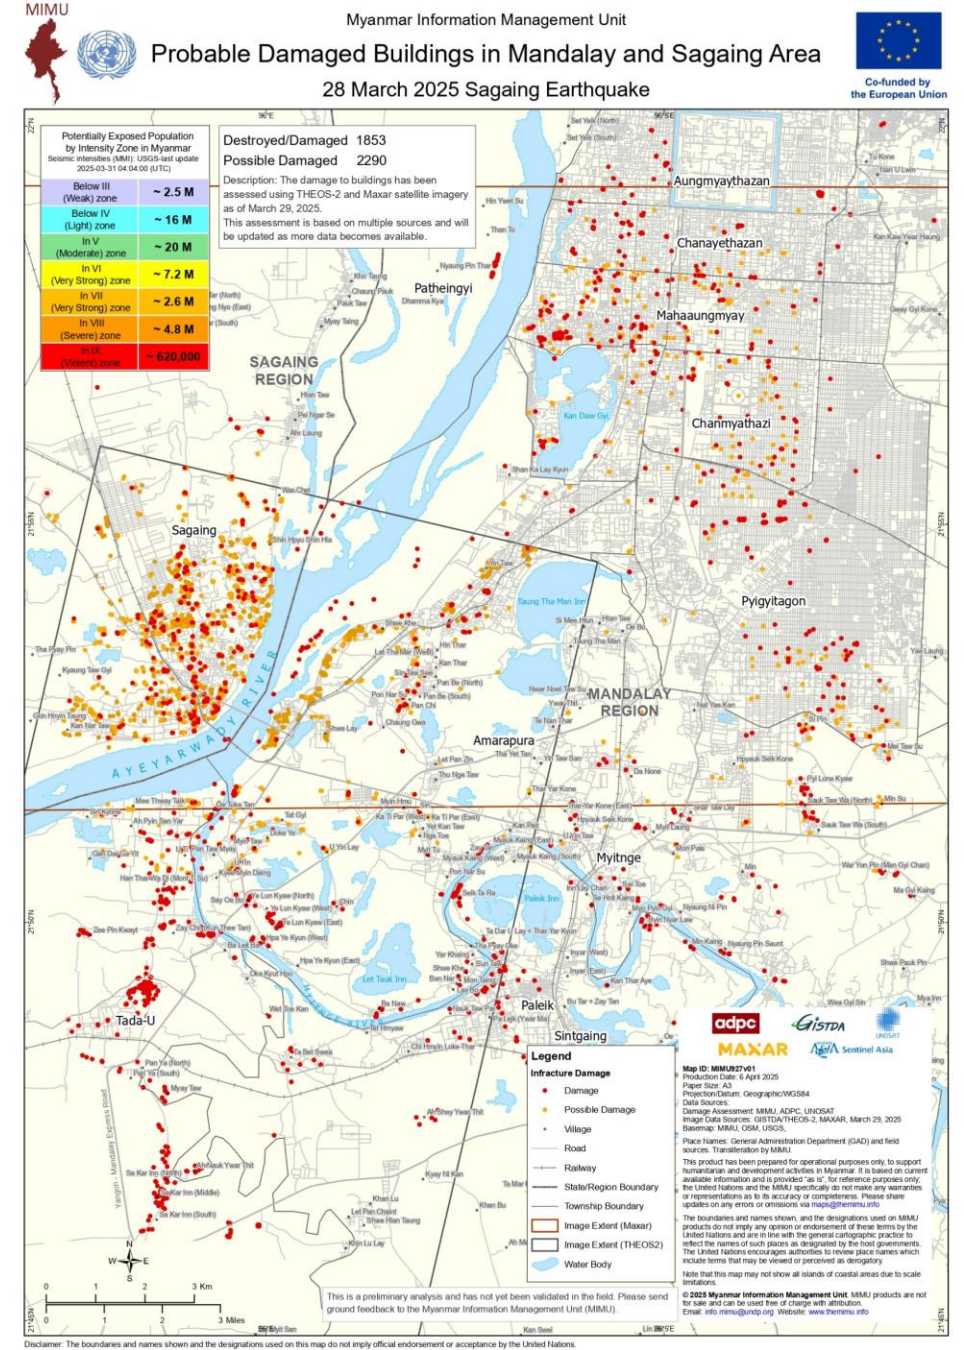
Probable Damaged Buildings in Mandalay and Sagaing Area is provided by MIMU. Destroyed/Damaged 1,853 Possible Damaged 2,290

The damage to buildings has been assessed using THEOS-2 and Maxar satellite imagery as of March 29, 2025.
